## TECHNICAL REPORT

Potable Well Water Quality Survey, Village of Spencerville  
Report Date: November 6, 2020

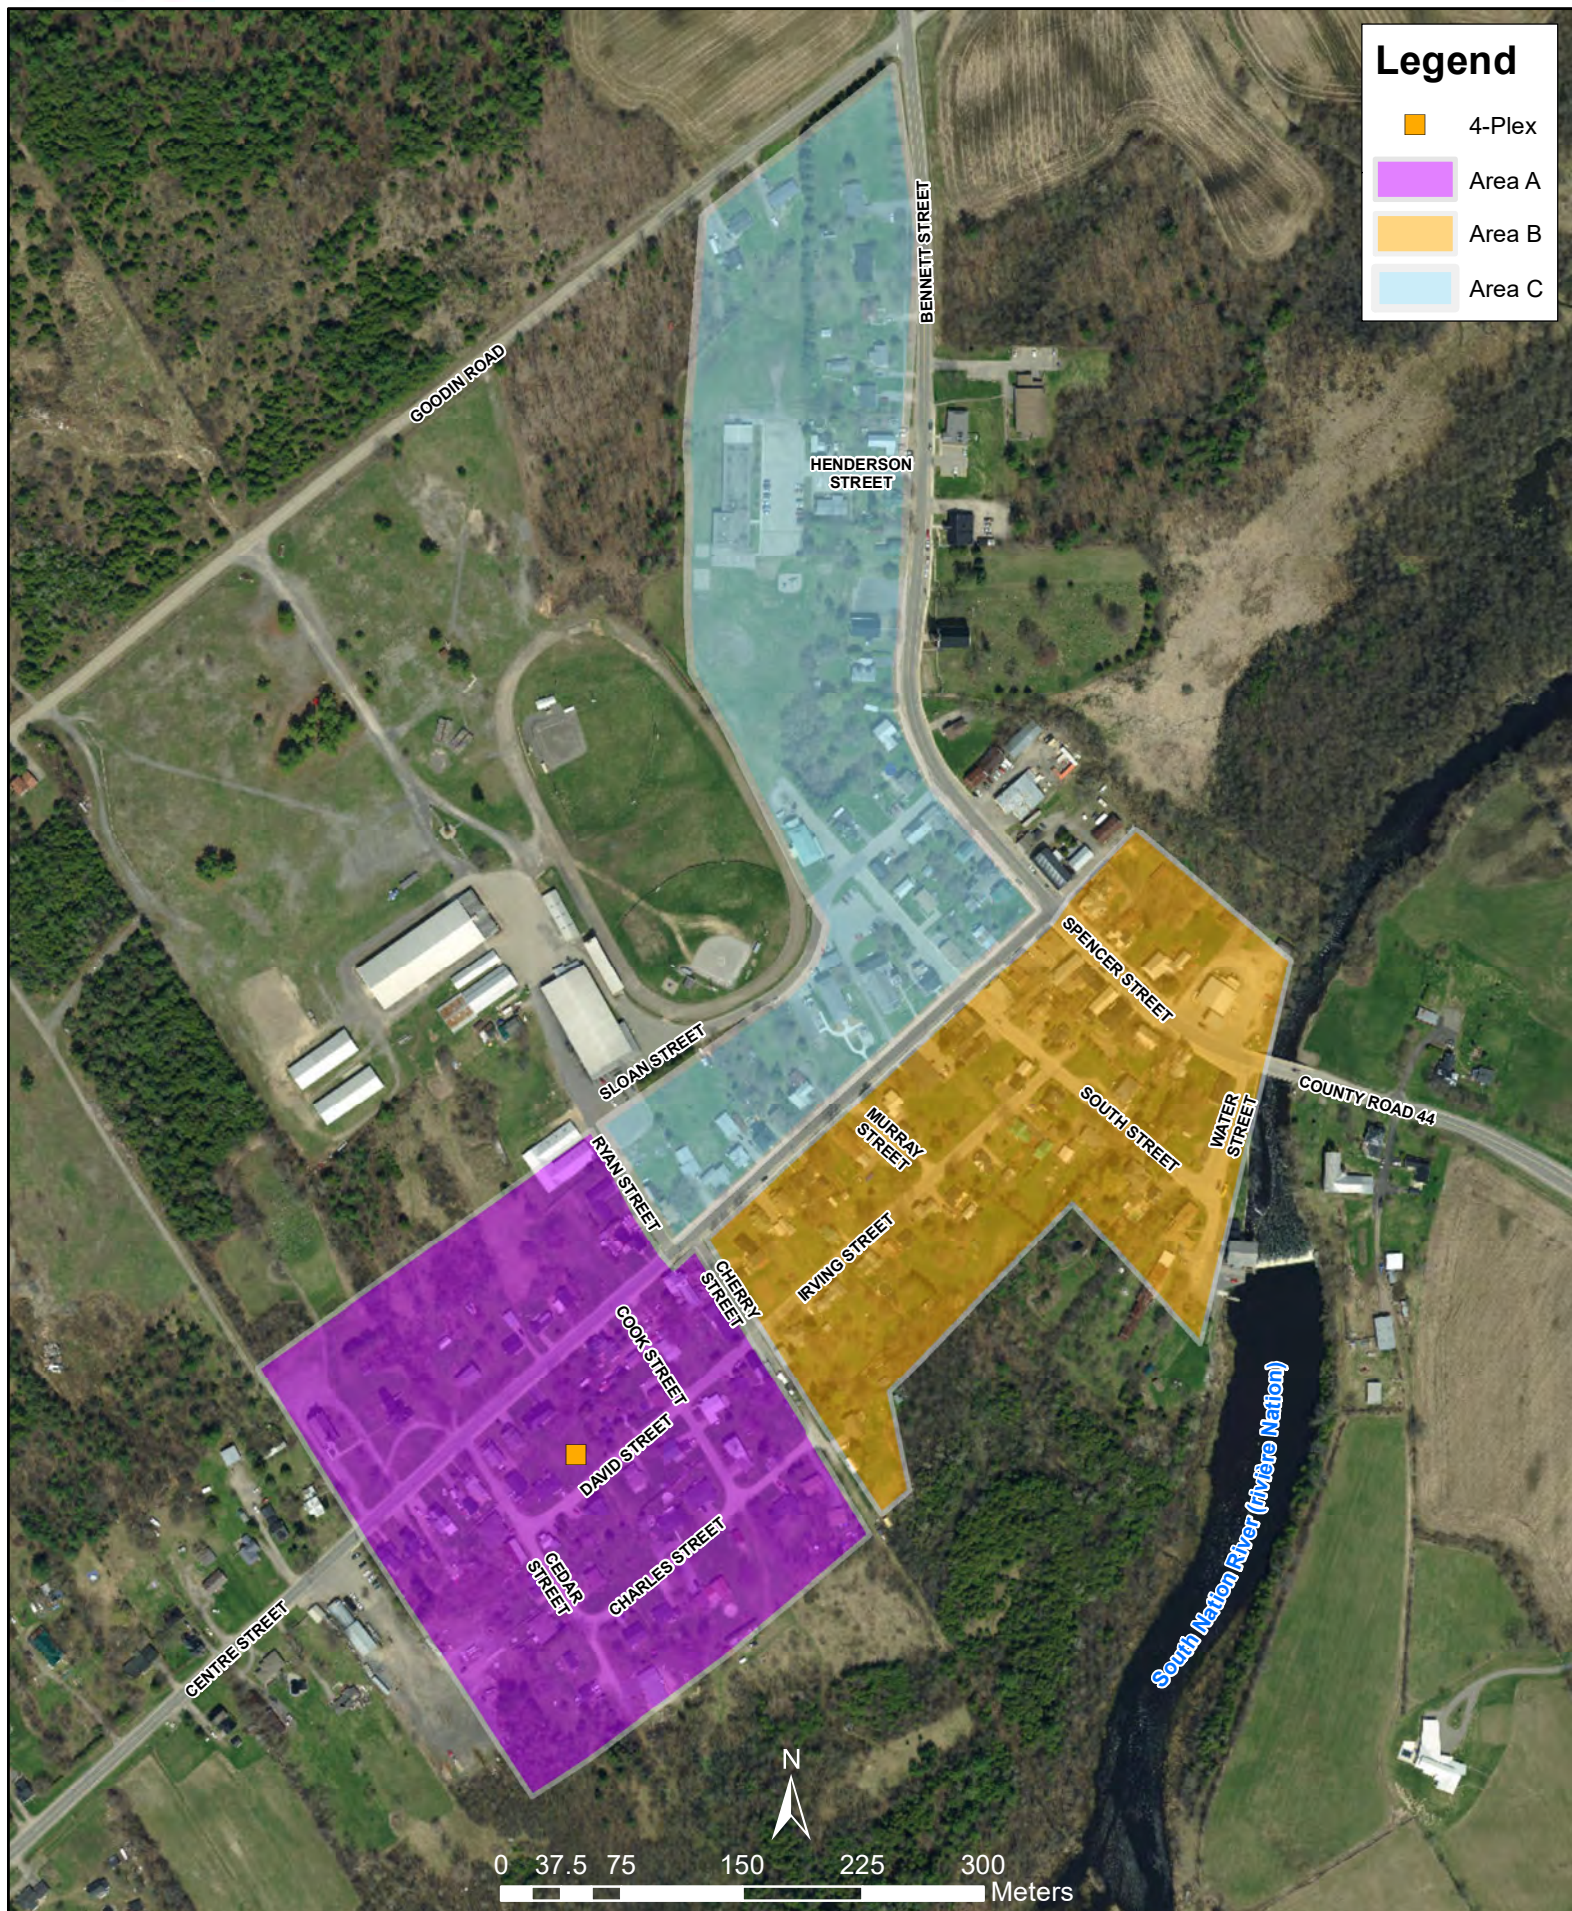
The study area and discussion areas are identified on Figure 1.
