**CORPORATION OF THE
TOWNSHIP OF EDWARDSBURGH CARDINAL**

**"A BY-LAW TO AUTHORIZE THE EXECUTION OF A DEVELOPMENT
AGREEMENT WITH MADISON MULDER ENTERPRISES INC."**

**THE TOWNSHIP OF EDWARDSBURGH/CARDINAL
DEVELOPMENT AGREEMENT**

Geotechnical Investigation & Slope Stability Study
Prop. Residential Development - 2017 County Road 2
Edwardsburgh/Cardinal, Ontario

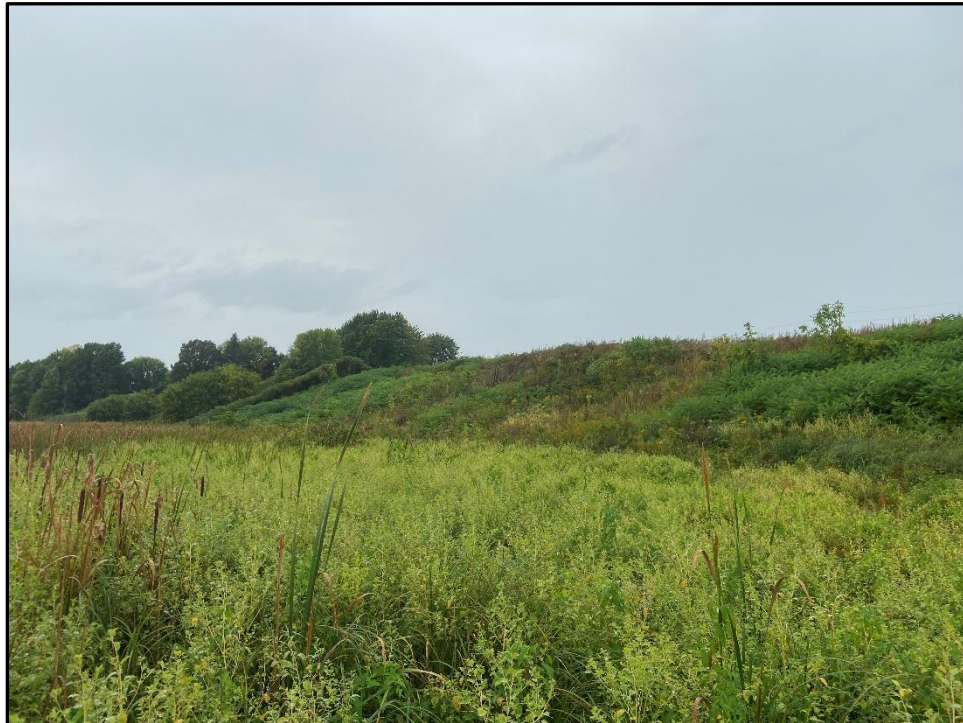
Photo 3: Photograph taken from the toe of the slope within the central portion of the site showing the face of slope. Most of the slope face and toe were observed to be densely covered by vegetation.

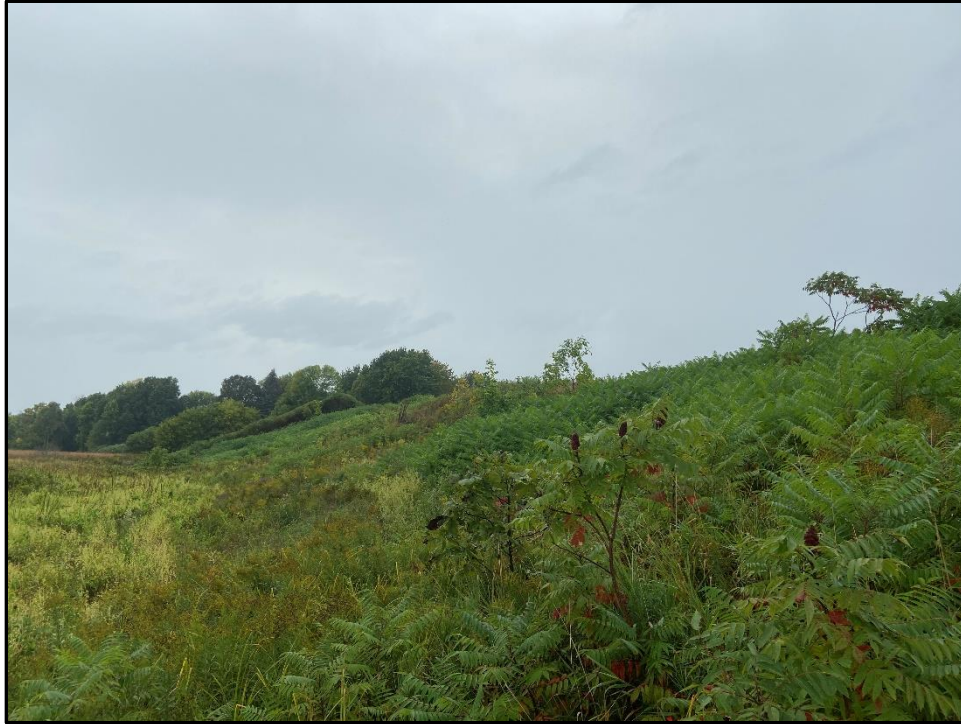
Photo 4: Photograph taken at the central portion of the site showing the face of the slope. Photograph taken from the side of the slope looking west.

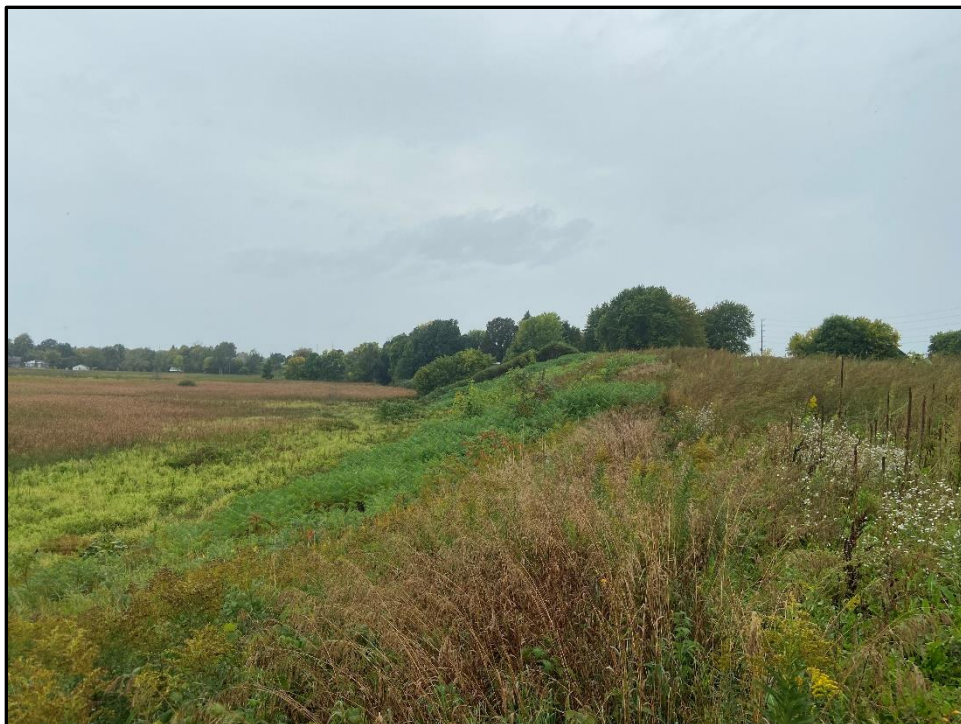
Photo 5: Photograph taken from the face of the slope within the central portion of the site showing minor, localized slip failures.

- Following geotechnical recommendations, no vegetation clearing is to take place on the slope face itself, as the existing vegetation cover on the slope provides additional stability to the slope and reduces surficial erosion due to surface water runoff.

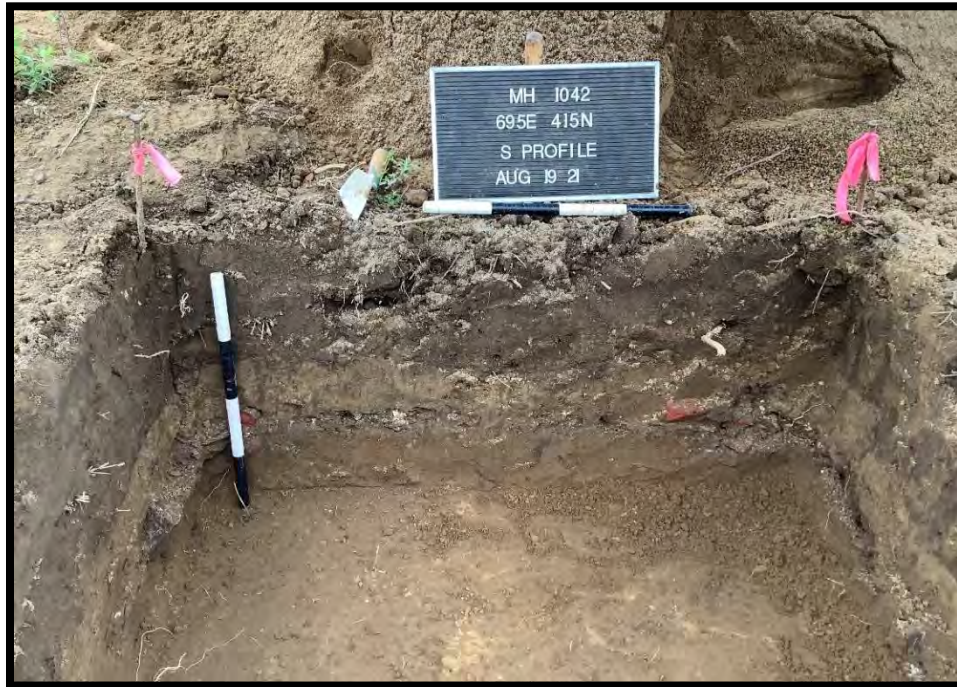
Figure 31: South profile of unit 695E 415N (MH1042-D059).

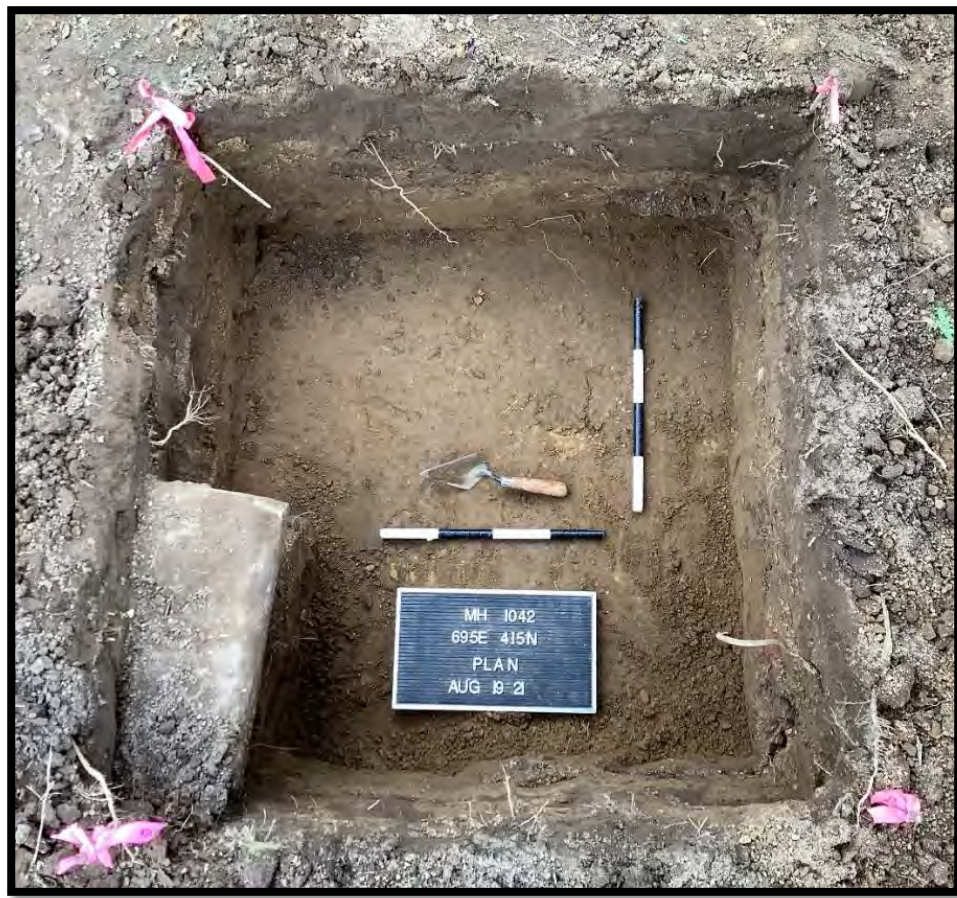
Figure 32: Plan view of unit 695E 415N (MH1042-D058).

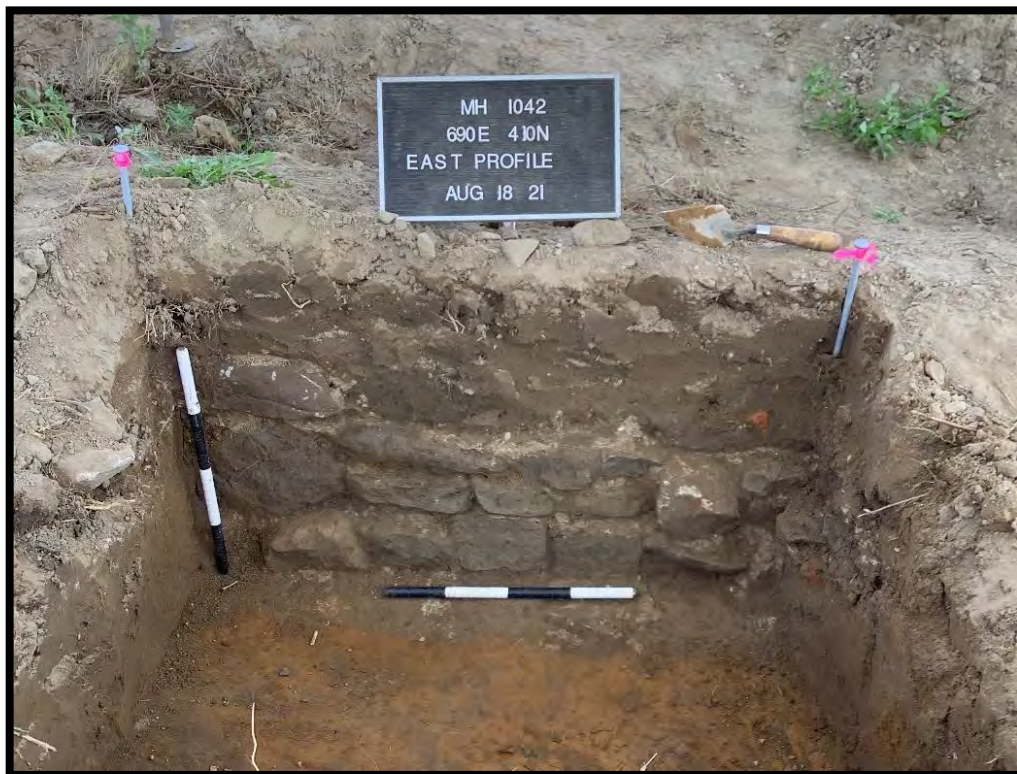
Figure 36: East profile of unit 690E 410N, exterior west wall of the foundation (MH1042-D053).

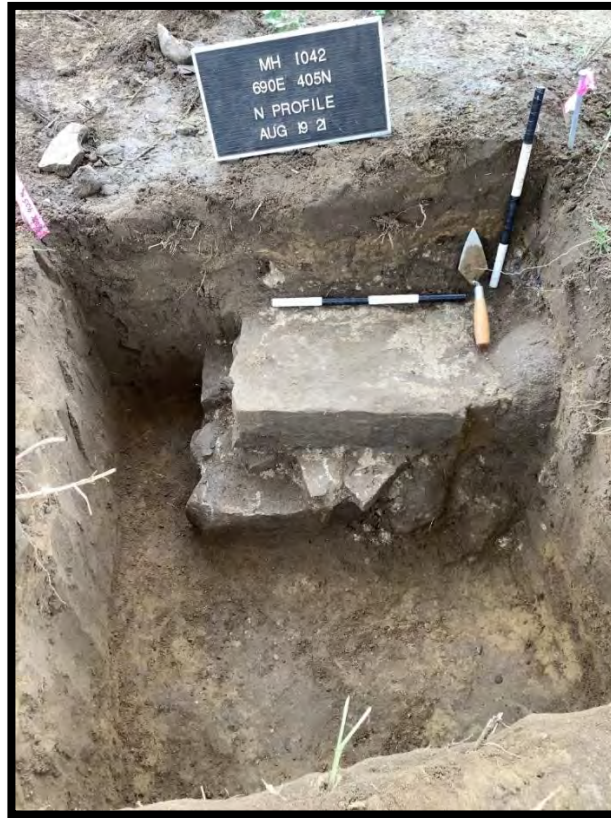
Figure 37: North profile of unit 690E 405N, corner of foundation (MH1042-D056).

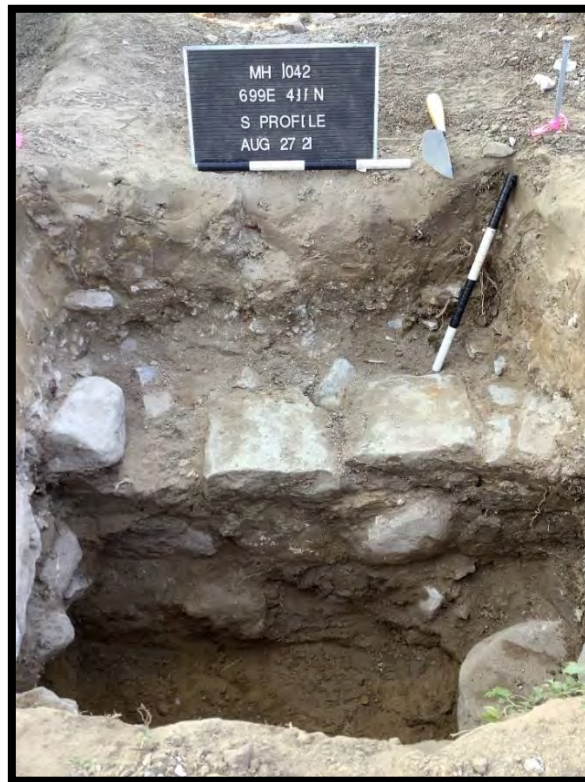
Figure 38: South profile of unit 699E 411N, exterior of northern wall (MH1042-D062).

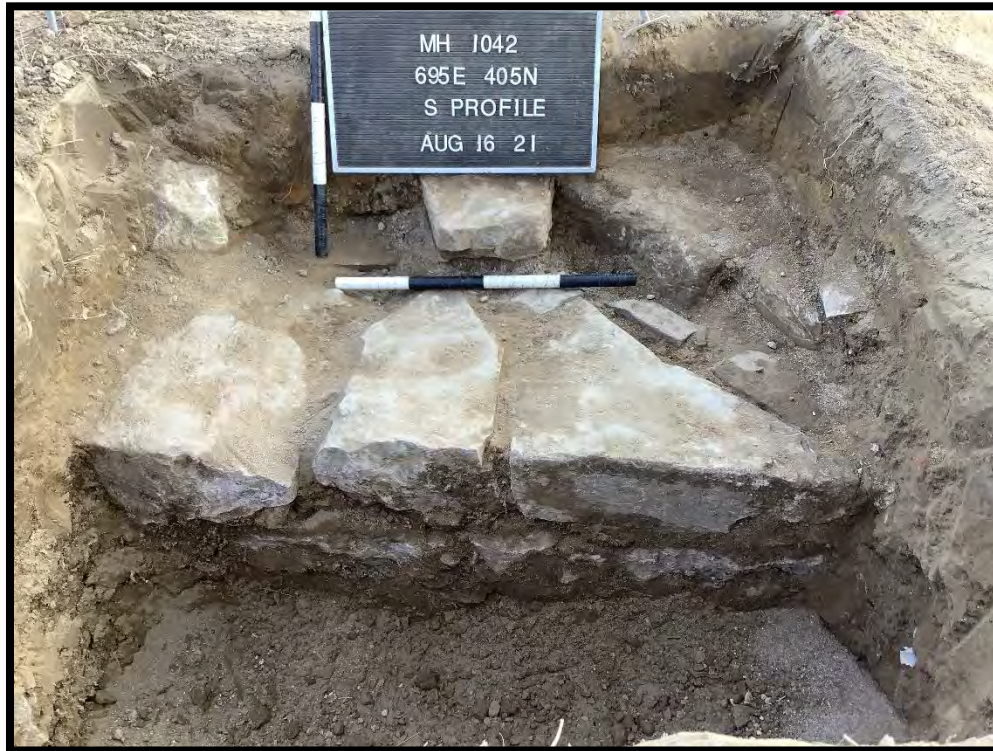
Figure 39: South profile of unit 695E 405N, interior of southern foundation wall (MH1042-D068).
